**REHABILITATION OF DEGRADED
LANDS USING VETIVER GRASS SYSTEM:
A CASE STUDY OF VOI RIVER BANK STABILIZATION IN COSTAL
KENYA.**

**Mr. Mwadime P.-Mseto Environmental Agency,
Dr. Maghanga J.K.- TTUC**

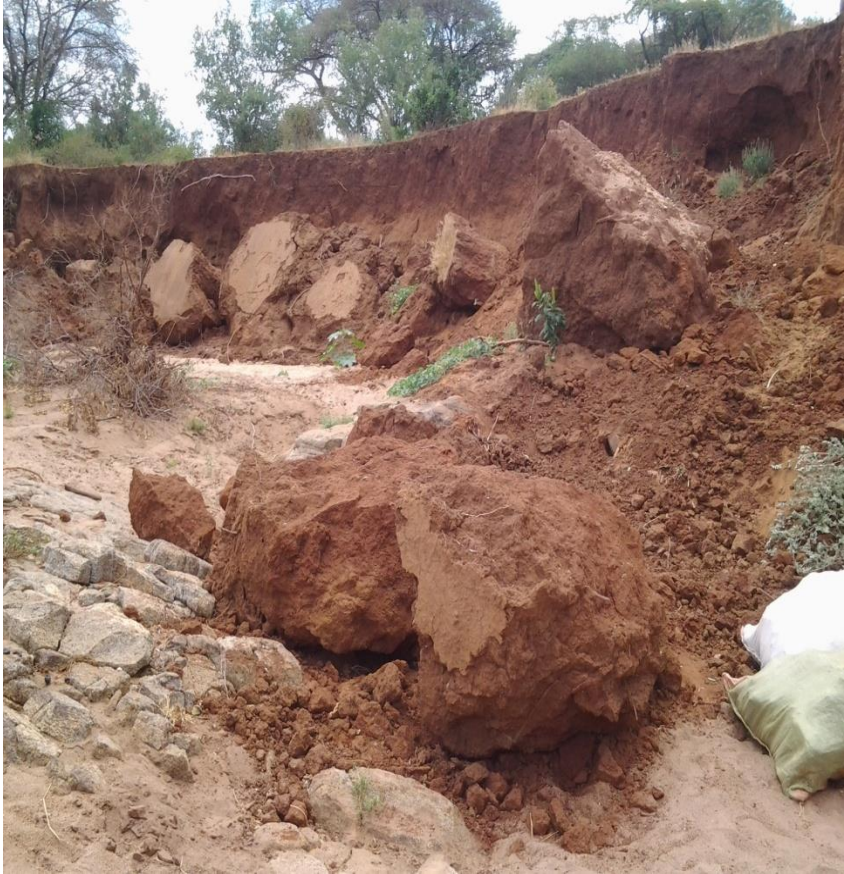
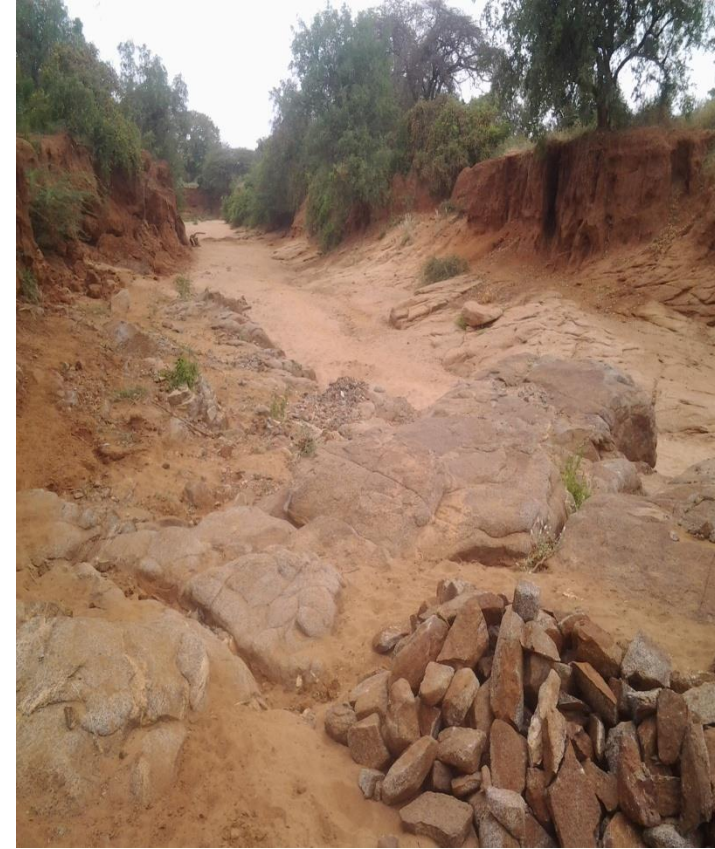
DEGRADED SOILS IN VOI

- **The area has poor plant cover, lack of drainage systems leads to erosion by both wind and water and due to (trees cut down for settlements). River bank collapse.**

- i. Unplanned settlements (such as Mwakingali, sofia area etc) have no good drainage and roof catchment ; leads to high volumes runoff creating gullies.**
- ii. Water flows freely from the hills down to the Voi river and the few roads are transformed into streams while gullies have been widened and deepened, and roads become impassable.**
- iii. Brick making -deforestation**
- iv. Uncontrolled grazing/Overgrazing**

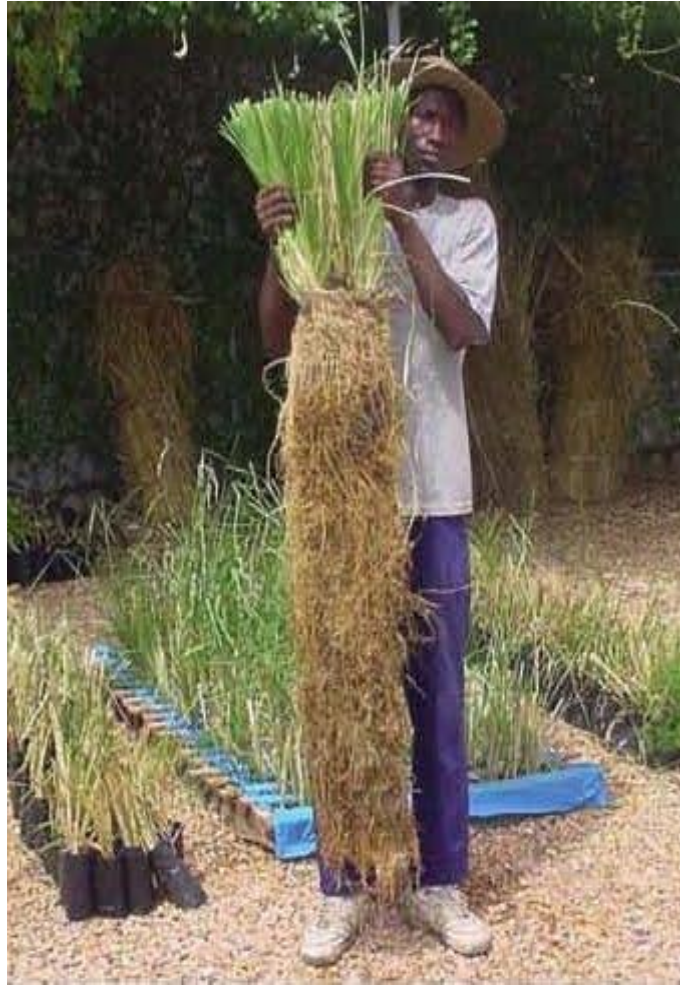
VETIVER NURSERY

- 1) Vegetative Propagation: Using various parts of a mother Vetiver plant . The splitting of tillers and cutting from a vetiver mature clump produce some kinds of planting materials (such as bare root slips, culm slips)
- 2) Bud multiplication: In vitro micro propagation
- 3) Tissue culture: Using a small part of the plant (shoot tips, young flower inflorescences or nodal buds)

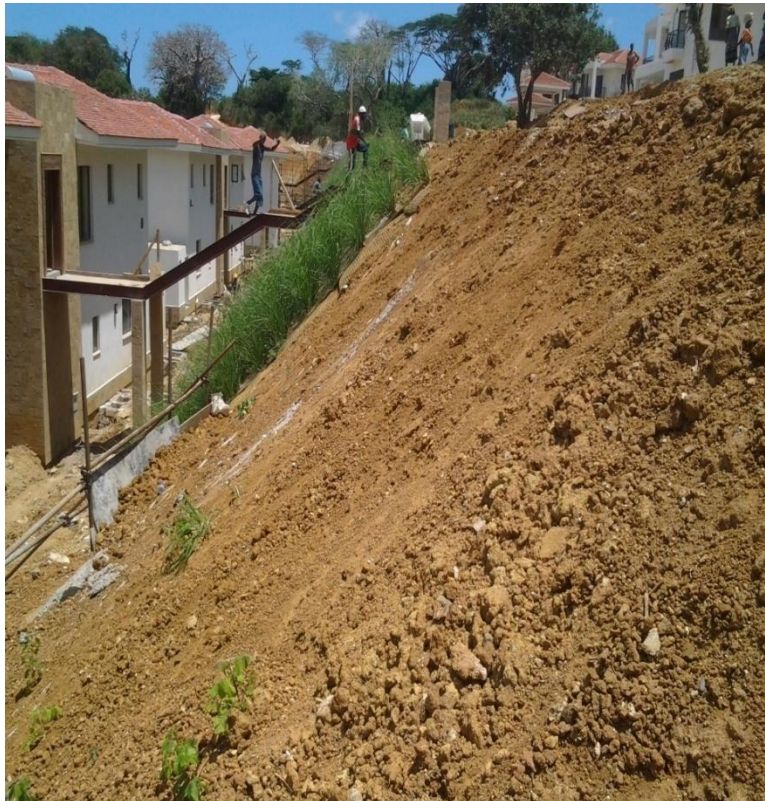
Bare

KILIFI MANDARIN ESTATE

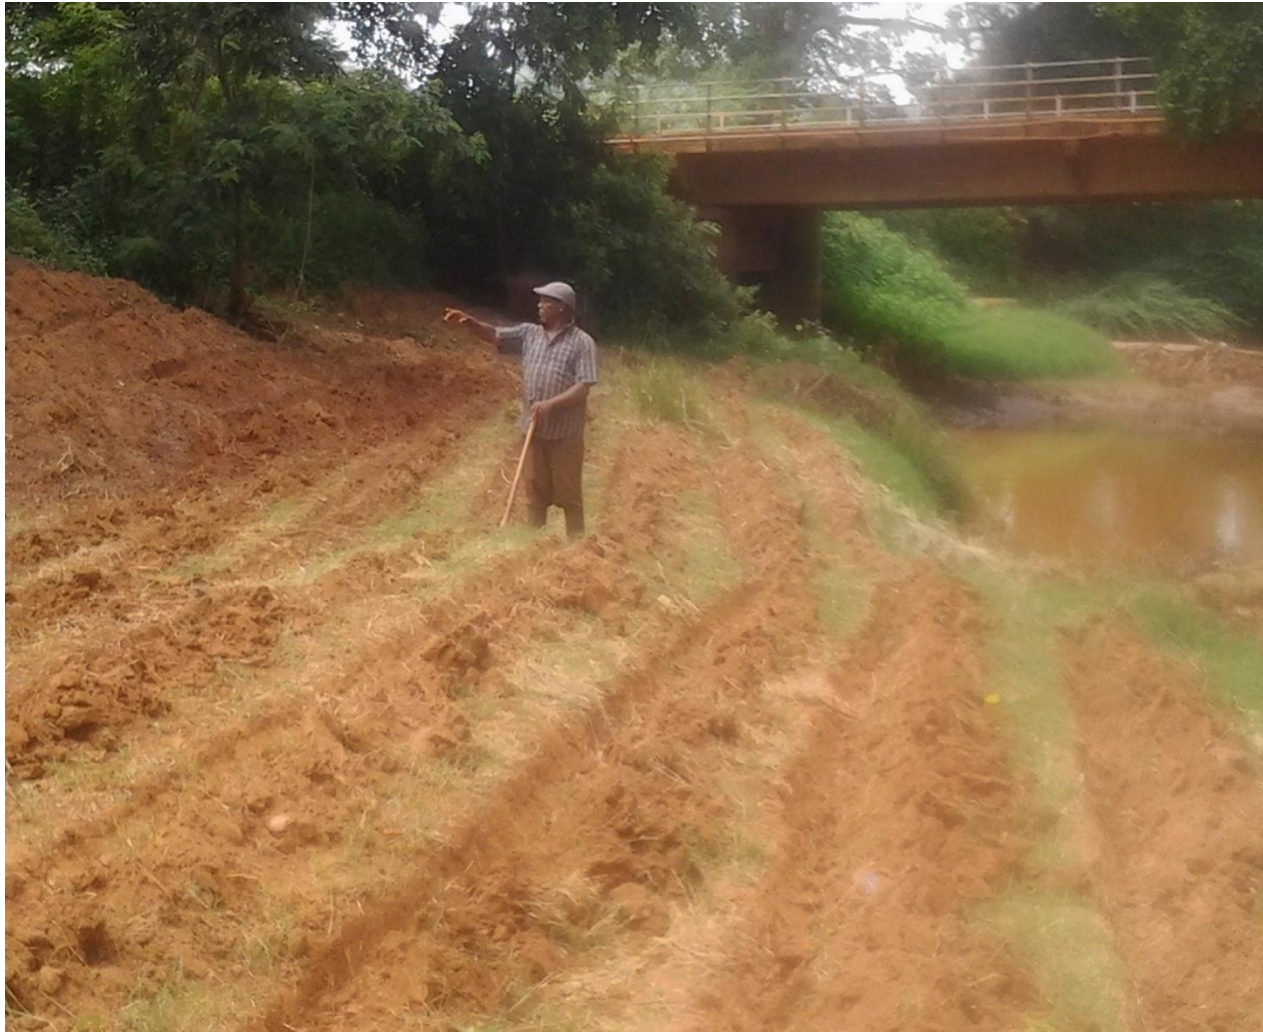
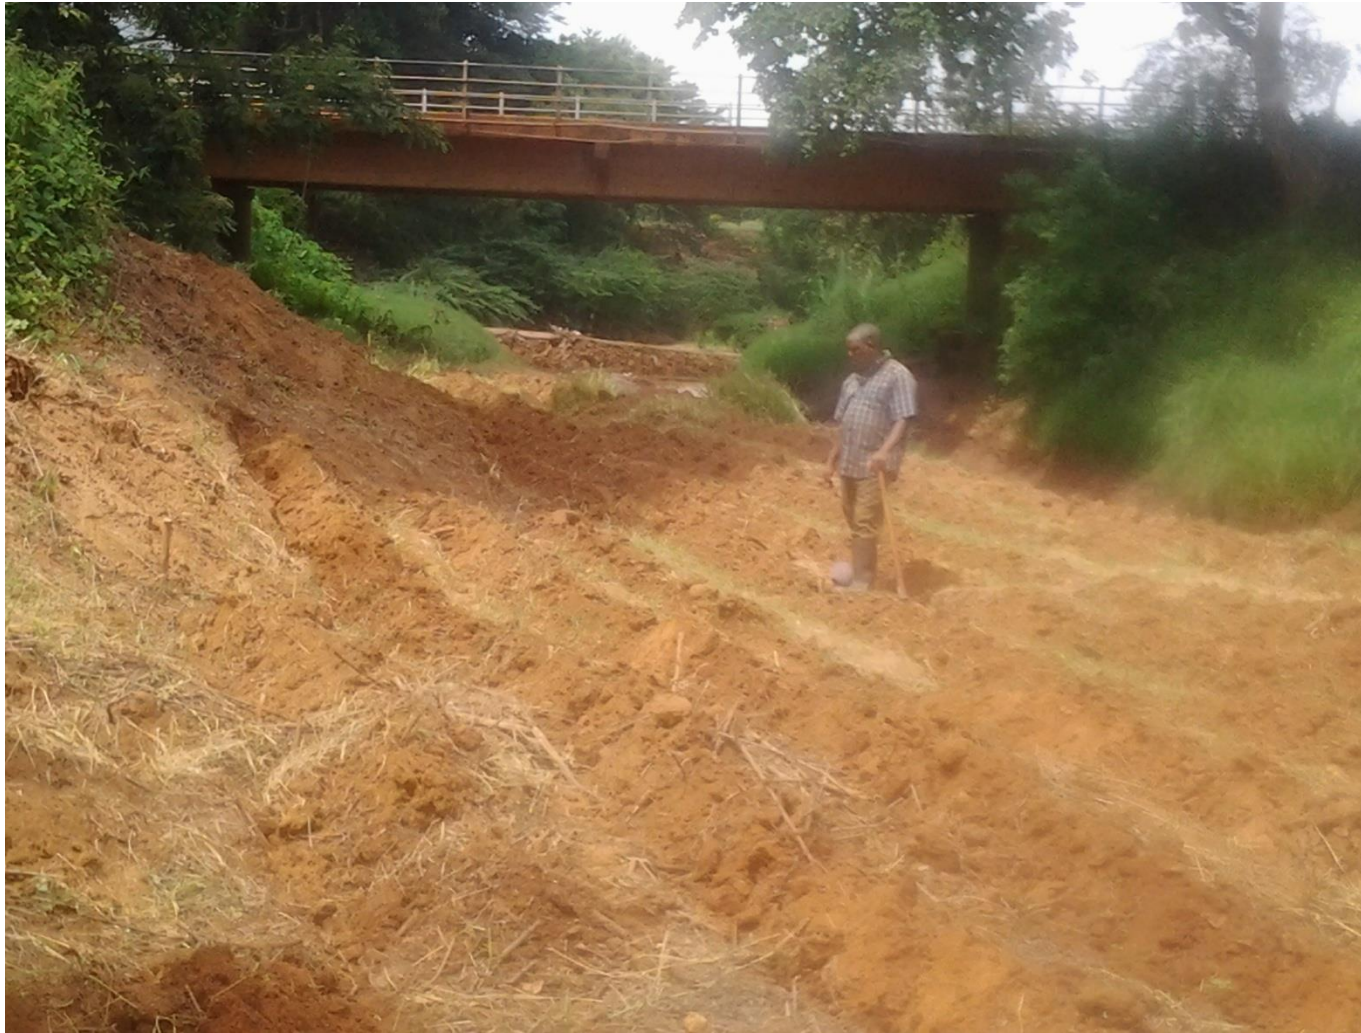
PREPARATION: DEGRADED VOI RIVER BANK

- An on-farm study was conducted at Voi River bank, along the bridge.
- Cultivars of *chrysopogon zizaniodes* were raised in a nursery for three months.
- Slips were transplanted along Voi river banks with a spacing of 1 m X 5 cm.
- NPK 17:17:17 was used during planting (5g/ slip)
- A total of 40,000 slips of Vetiver were planted during January-February 2016

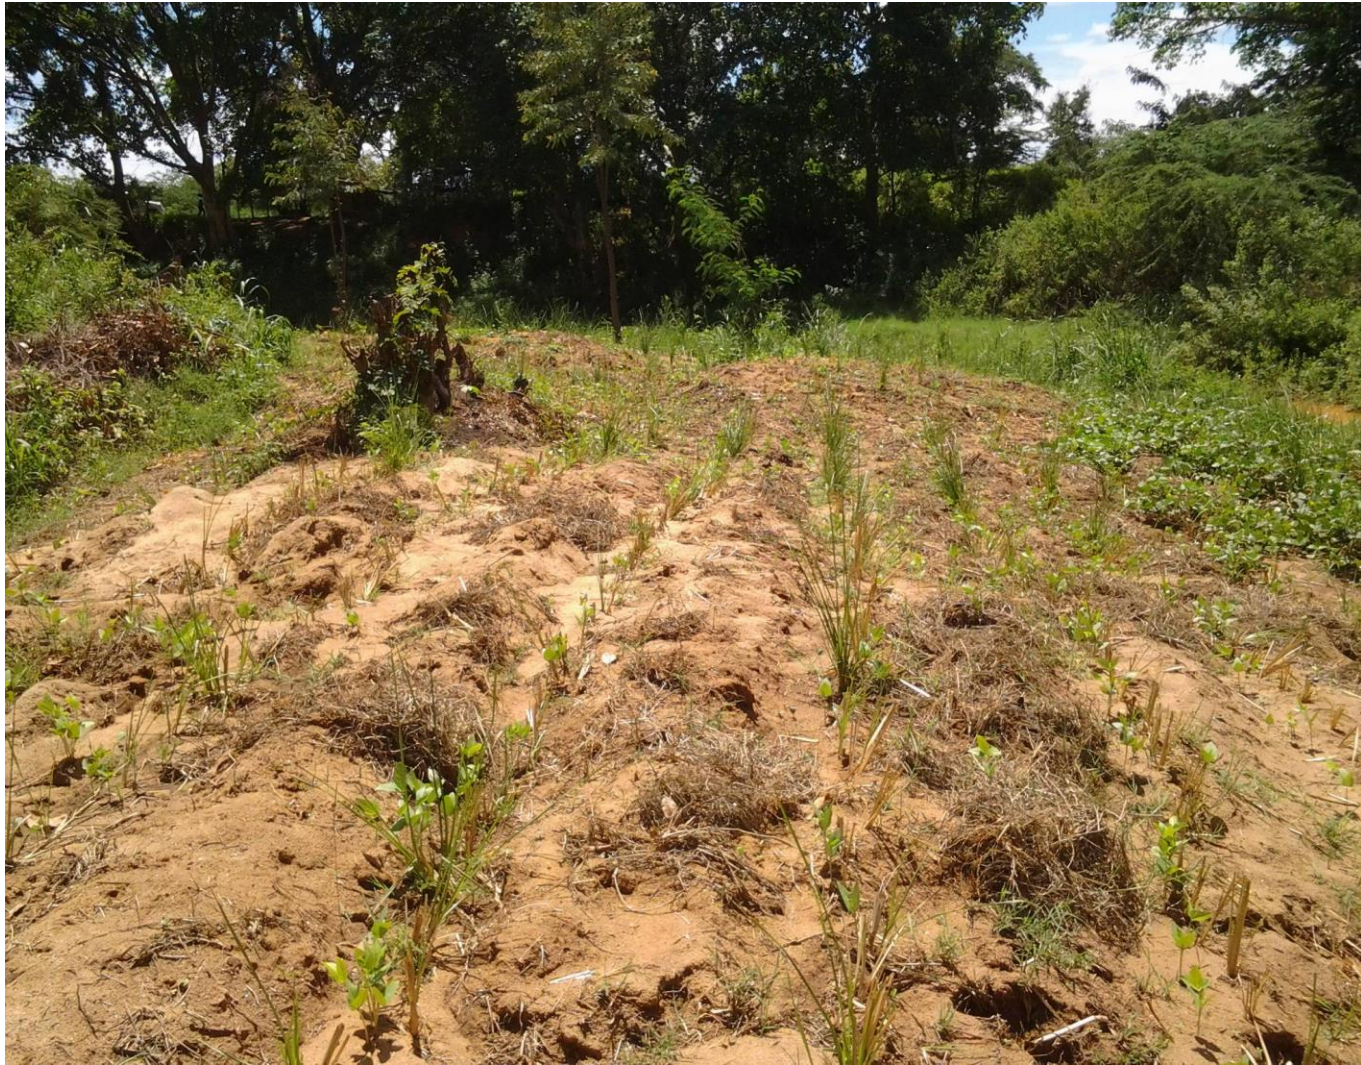
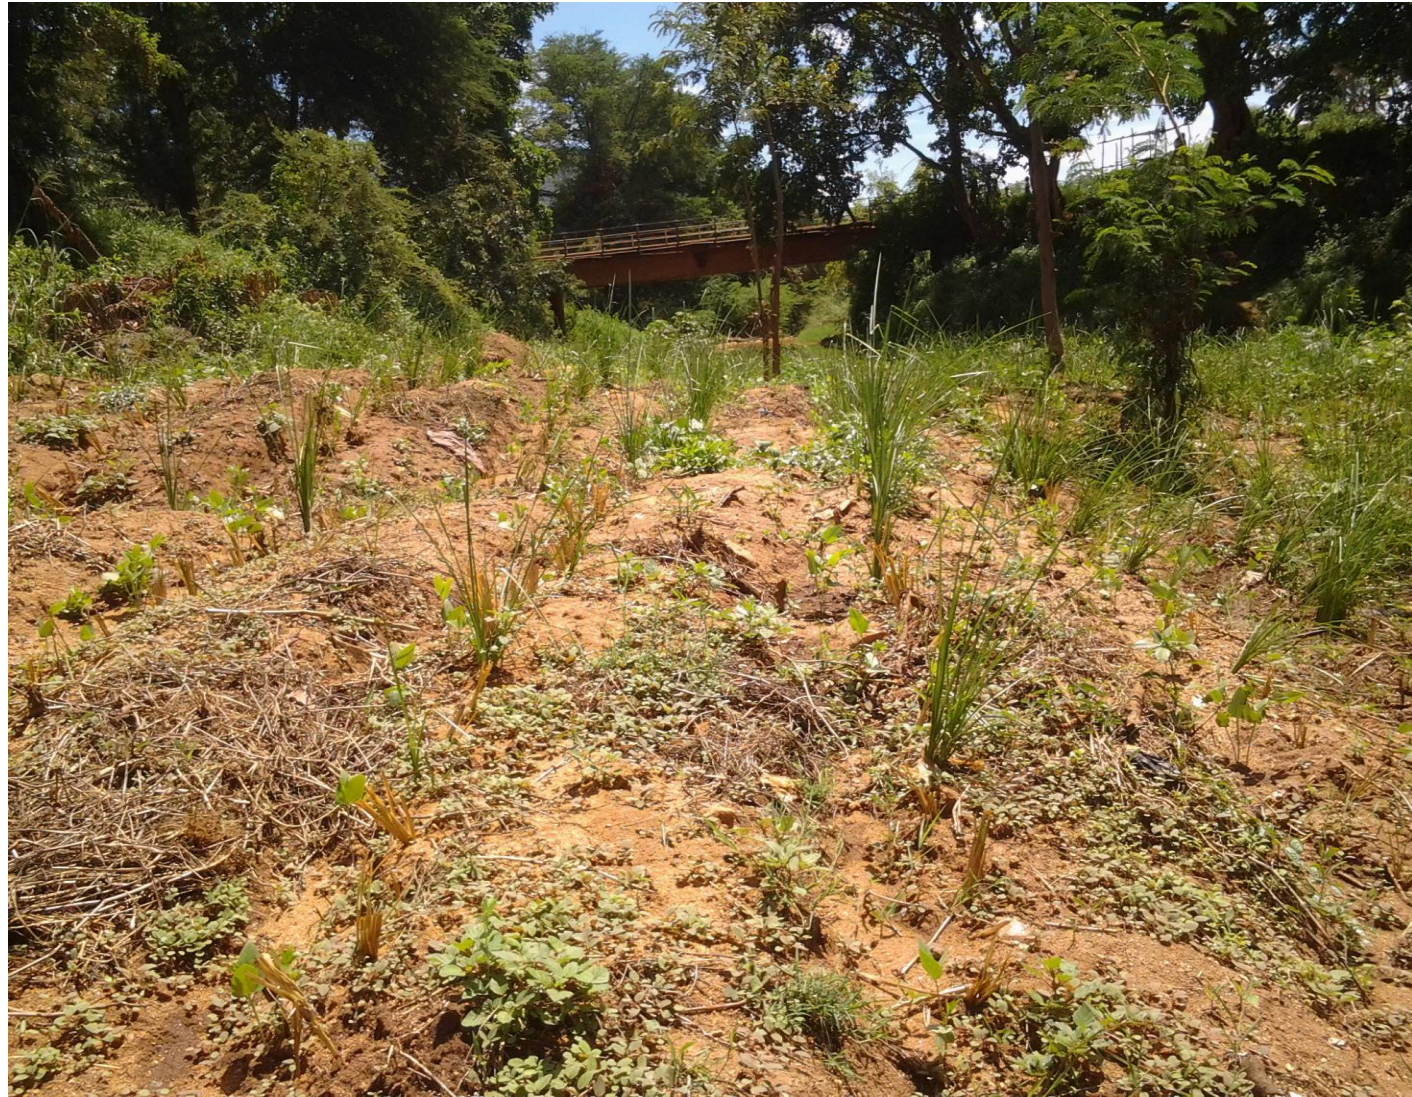
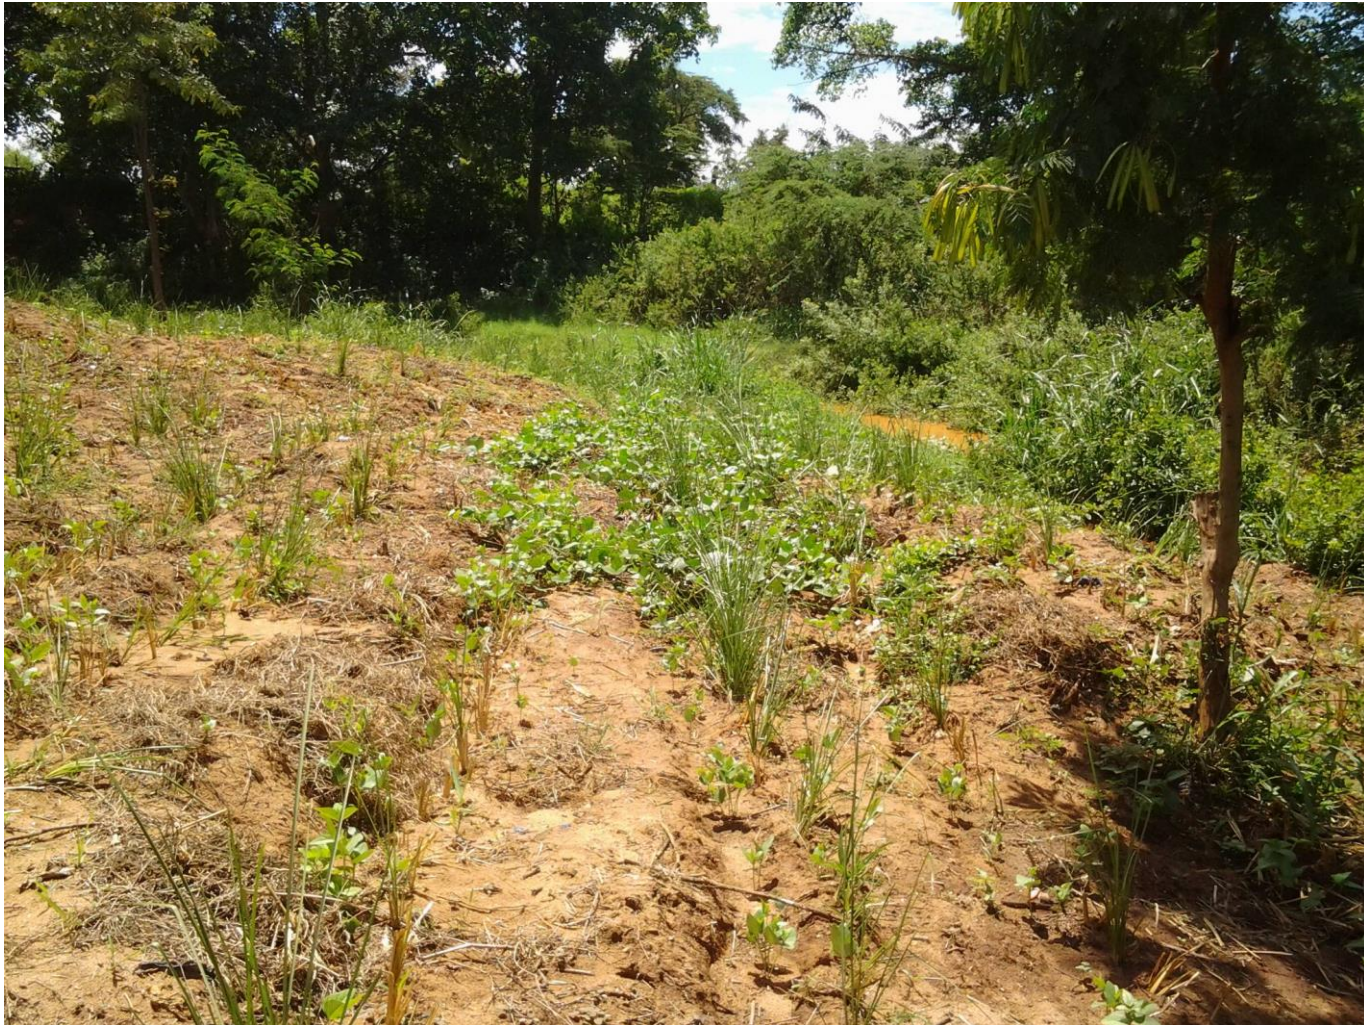
1 MONTH

- **Between 1-4 months: plant cover approx 75% and a massive root structure was well developed that stabilized the soils.**
- **VS was found effective in the protection of Voi river banks from erosion.**
- **NPK (17:17:17) fertilizer necessary to supply nutrients during planting.**
- **VS found to reduce rainfall runoff: this would improve ground water recharge.**
- **The cost of planting: approx. USD 2800/acre. However once planted, there is vibrant multiplication of the grass and slips can be obtained for planting from mother bush.**
